CASE STUDY

MOGAS supplies replacement valves and service contracts to improve autoclave operations

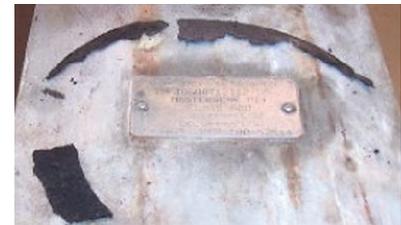
These pieces are all that remain after the Belleville springs dissolved in a competitor's super duplex valve.

The first failures occurred with the super duplex valves. The Belleville springs dissolved, resulting in the ball dropping within valve body. More failures came from inadequate coating on super duplex and titanium valves, resulting in the coating completely wearing off.

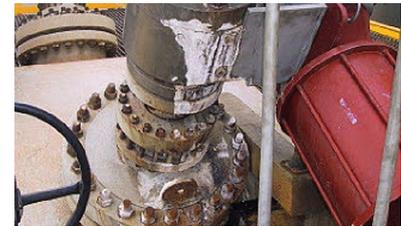
Competitor's valve leaked acidic slurry.

Another major failure occurred when the small peek inner stem seal was severely damaged, due to the actuator bracket twisting and distorting when the valve was opened or closed—causing the stem to deform. This resulted in acidic slurry leaking out through the packing area, leading to corrosion in the stem packing area.
