MOGAS M7
A PERFORMANCE ENHANCED NANO STRUCTURED TITANIUM DIOXIDE COATING
IN HPAL AND POx BALL VALVE APPLICATIONS

¹MOGAS Industries, Houston, Texas, USA

ABSTRACT

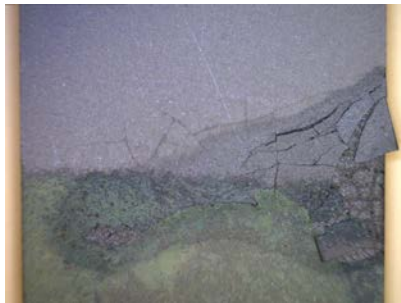
Thermally induced cracking is another in service phenomenon of concern on Superaustenitic/ Ceramic coating combinations due to the high mismatch of Expansion Coefficients between ceramic coatings and austenitic base metals. Figure 3 shows thermally induced cracks on a n-TiO₂/Alloy 20 coupon after heating to 600 °C (1,112 °F) and rapid quenching in cold water. This test was performed at temperatures way out of the range of normal autoclave operating temperatures, however, no corrosive or abrasive media were present. When tested at elevated temperatures (600 °C/ 1,112 °F) cracking was observed after 10 thermal cycles, when repeated at actual operating temperatures (230 °C/ 450 °F), no thermal cracking occurred.

Figure 3: Thermally induced cracks on a n-TiO₂/Alloy 20 coupon.

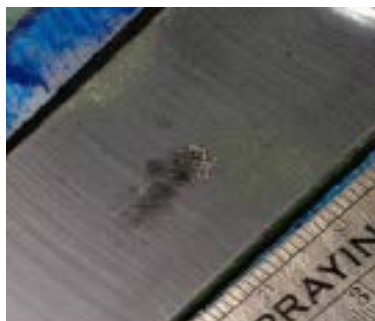
The photograph in Figure 7 was taken after low-load impact testing and shows the onset of coating damage after a number of impacts.

Figure 7: Photograph of a n-TiO₂ coating sample following impact test.

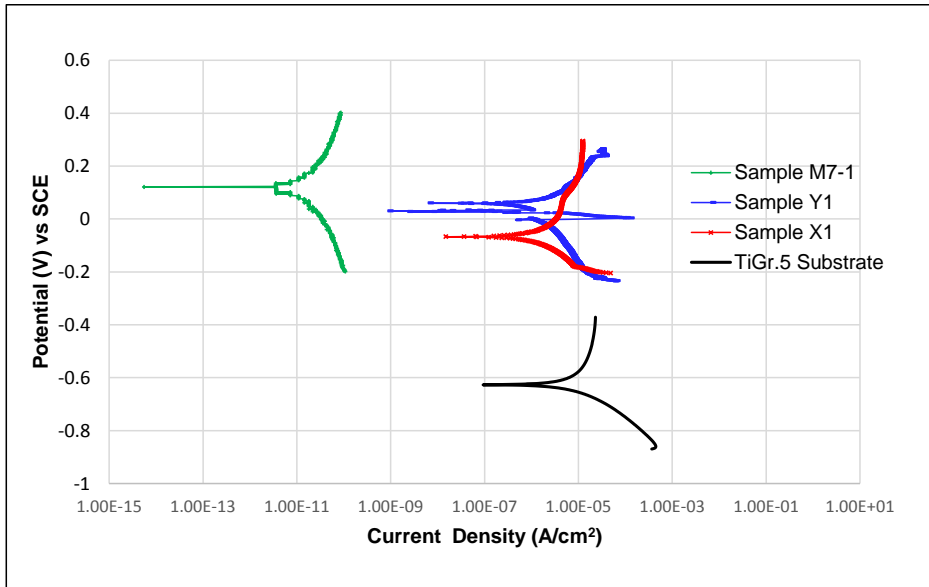
Figure 10a: Polarization curves for samples X1, Y1, M7-1 and Titanium Gr.5 substrate tested in a 50:1 solution of H₂SO₄ (acid) and NaCl (salt).

Although the coating and substrate materials were the same for each group, there was significant difference in the corrosion properties between the samples. All coated samples of each base metal group exhibited higher E_{corr} and lower i_{corr} values compared to bare Titanium Gr.5 and Fe255 substrates.

As with the OCP results, the higher E_{corr} is a reflection of the barrier role the n-TiO₂ coating plays in mitigating attack of the electrolyte to the underlying Titanium Gr.5 and Fe255 substrates. The bare Titanium Gr.5 and Fe255 substrates showed a greater vulnerability to attack by the electrolyte. The most favorable results were observed in samples M7 with the highest E_{corr} and lowest i_{corr} . The corrosion rate, e.g., i_{corr} , does not correlate with the porosity levels observed for the samples; however, this may be due to the presence of other pathways (e.g., microcracks, gaps between splats) in the coating for the electrolyte to permeate to the substrate that was not identified within the scope of this work.

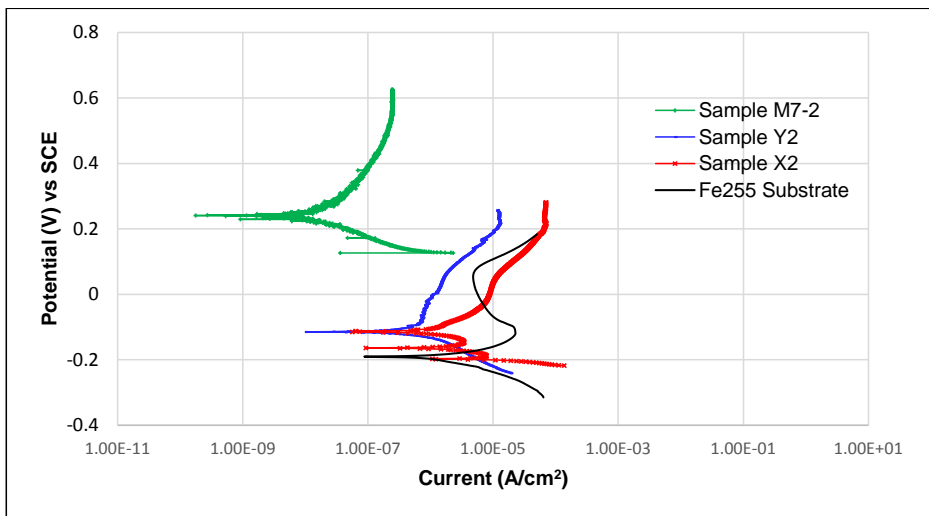
Figure 10b: Polarization curves for samples X2, Y2, M7-2 and Fe255 substrate tested a 50:1 solution of H₂SO₄ (acid) and NaCl (salt).

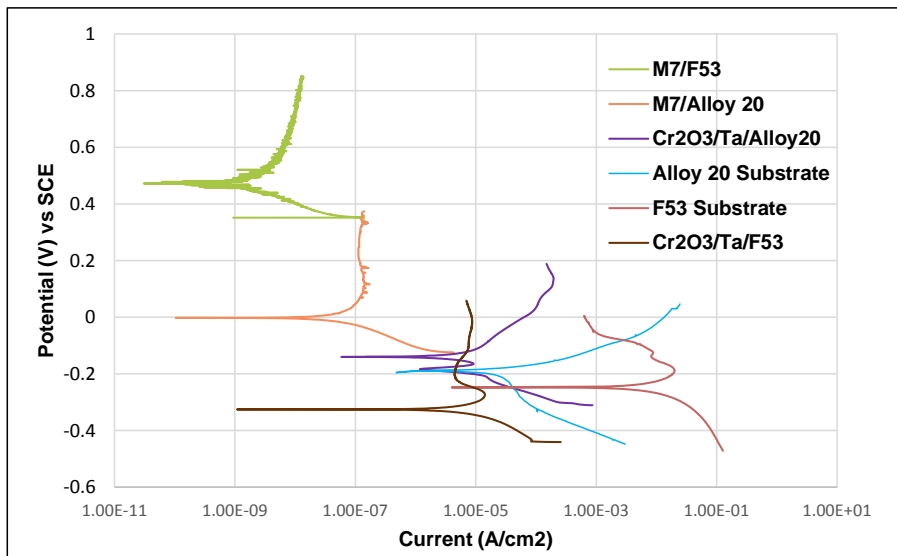
The electrochemical characteristics shown in Figure 13 and Table 4 further confirm the benefits of using M7 on F53 substrates rather than on Alloy 20. The superior performance of M7 on both substrates is also clearly seen over the commercial Cr₂O₃ coating (with a tantalum bond layer) since the M7 coatings exhibit higher E_{corr} (corrosion barrier) and lower i_{corr} (rate of corrosion) values than the Cr₂O₃ coatings.

Figure 13: Polarization curves for Sample M7/F53, M7/Alloy 20, Cr₂O₃/Ta/F53, Cr₂O₃/Ta/Alloy 20 and bare F53 and Alloy 20 substrates tested in a 50:1 solution of H₂SO₄ (acid) and NaCl (salt).

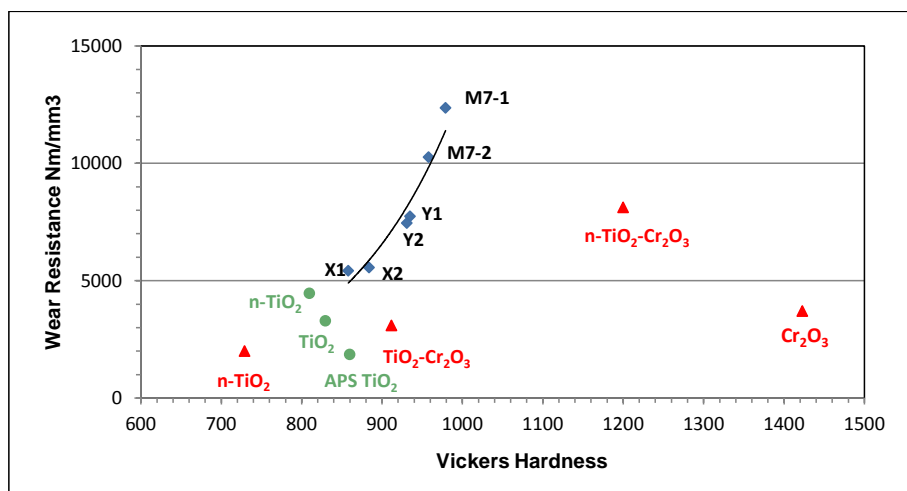
The diamond symbols report wear resistance results from MOGAS samples X, Y, M7 tested using ASTM G65 procedure B, with material loss reported after 2000 cycles. The triangle symbols are the published samples⁽¹⁷⁾ tested using a modified ASTM G65 procedure D with a lower applied load (45N vs. 130N used in other abrasion tests) but with 2000 revolutions instead of the 6000 revolutions called for by procedure D. The circular symbols are the published samples⁽¹⁸⁾ tested using ASTM G65 procedure E, in this case material loss is reported after 1000 cycles (half of the number of cycles that MOGAS coatings were tested to).

Although the MOGAS adopted ASTM G65 procedure B has more severe test conditions than ASTM G65 procedure D and E, MOGAS M7 coatings still significantly out perform all other coatings in abrasion resistance. It is important to note that the higher hardness associated with Cr_2O_3 coating does not translate to higher abrasion resistance. The abrasion resistance evaluation results have further confirmed our previous findings that a combination of hardness and ductility for a ceramic coating is more advantageous than those coatings that only exhibit high hardness.

Figure 18: Abrasion resistance of sample X's, Y's and M7's and published similar coatings.

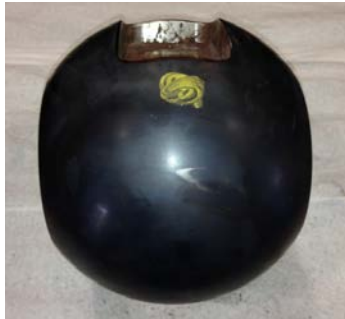
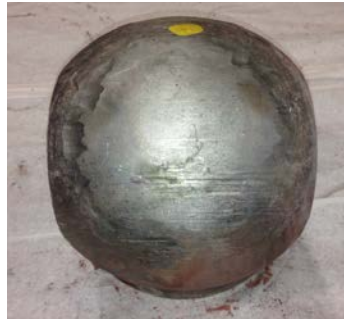
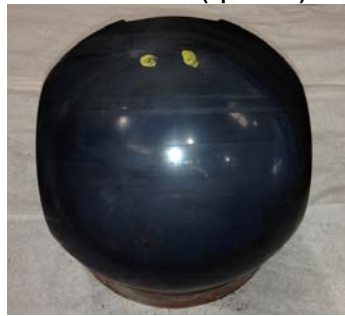
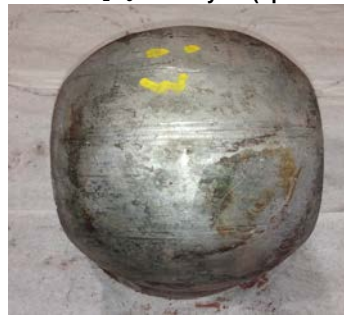
The photographs presented in Figure 19 compare the performance of our M7 coating and a conventional structured Cr_2O_3 coating from another valve manufacturer on 6" (150mm) Alloy 20 balls in oxygen supply service. The two valves had been installed in the same autoclave location and subjected to the same temperature, pressure and process media. Both valves were sent to MOGAS for service and coating evaluation after 6+ months in service. The photographs on the left are taken of the MOGAS ball with M7/F53 material. The photographs on the right are the other valve manufacturer's ball with $\text{Cr}_2\text{O}_3/\text{Ta}/\text{Alloy 20}$ material. After facing the identical service conditions, the MOGAS coating showed only minor surface scratching due to normal mechanical cycling. However, the coating supplied by the other valve manufacturer failed in service as a result of galvanic corrosion causing total coating loss and then erosion to the base metal. The only way coating materials could be identified on the other manufacturers valve was using X-ray diffraction methods from the coating residue found on the ball bore and on the seats.

MOGAS M7/F53 (upstream)

OTHER Cr₂O₃/Ta/Alloy 20 (upstream)

MOGAS M7/F53 (downstream)

OTHER Cr₂O₃/Ta/Alloy 20 (downstream)

Figure 19: Photographs of field returned n-TiO₂ and Cr₂O₃ coated balls of 6" (150mm) autoclave isolation valves after more than 6 months service – M7/F53 (left) and Cr₂O₃/Ta/Alloy 20 (right).
