TechTalk

Advanced MOGAS metallurgically bonded overlay extends equipment operability

ML-381 Metallurgically Bonded Overlay

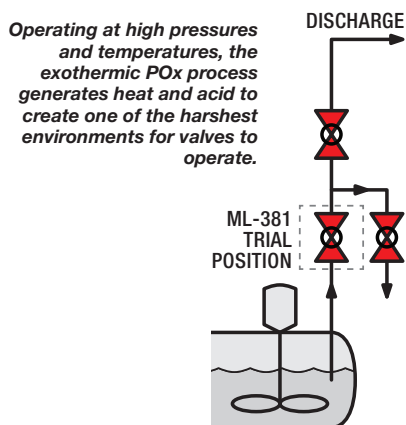
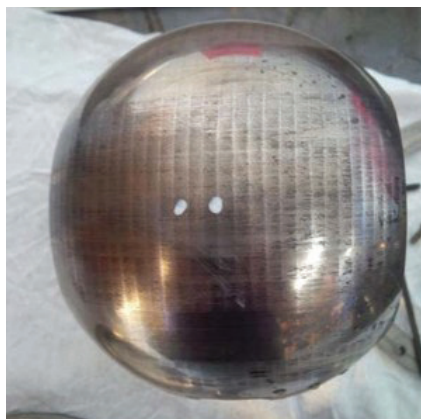
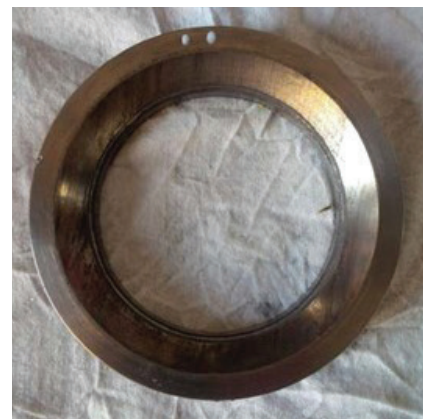
ML-381 parts manufactured for 10-inch, ASME 600 Class valve.

A 10-inch, ASME 600 Class ML-381 trial valve was installed in the primary (inboard) discharge location at the site in November 2016. The autoclave was operated at 419° F (215° C), 450 psig (3100 kPag), with free acid levels of 35 to 40 g/L H₂SO₄ over the course of the trial. MOGAS inspected the valve during two opportunities (April and August 2017), and during both inspections the valve condition was satisfactory to be reinstalled in service again.

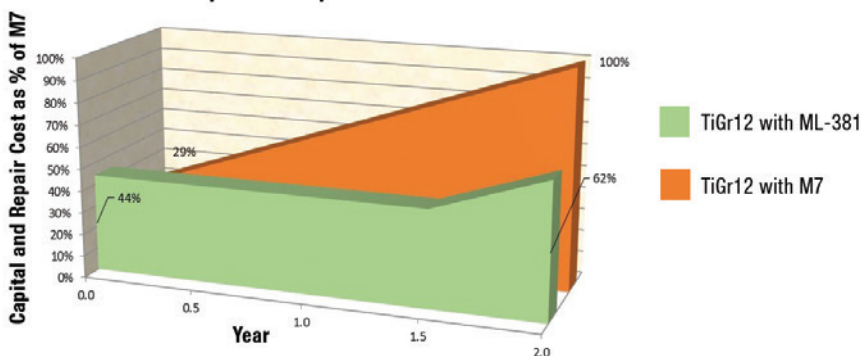
Ownership Cost Comparison: ML-381 vs M7

ML-381 outperformed existing valve coatings, promising a reduced cost of ownership.

- potentially extending operating campaigns between shutdowns, thereby maximizing annual production potential
- the scope for applying ML-381 on other pieces of titanium equipment in the pressure leach circuit that are experiencing significant wear, such as agitator blades and discharge strainers
- the valve's internal rate of wear is significantly lower than that of the M7 coating previously supplied, despite the longer time in service. This implies approximately 38% lower ownership costs compared to that of M7.
