CASE STUDY

High pressure and erosion jeopardize safety and profits in water cutting application

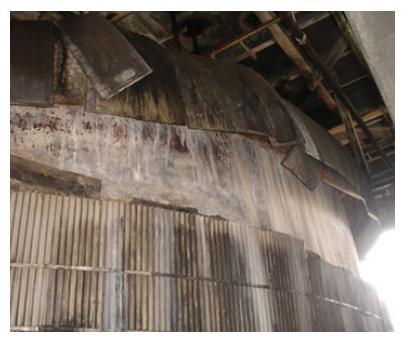
Leaking water from a competitor's valve caused damage to the coke drum's thermal insulation.

When in the closed position to isolate, the valve—a competitor's 6-inch, ASME 2500 Class valve originally sold as part of the pump package—leaked large amounts of water through the valve's packing onto coke drums, causing the drum to buldge and deform. This, coupled with the country's high humidity, caused the thermal insulation on the coke drum to fail. Coker drums reach 925° F (496° C), and the heat from the uninsulated drum was suffocating to plant employees. The leaking water also produced an unsafe environment on the upper deck, and dripped on to instrumentation and wiring on the lower deck creating a safety hazard.
